PM9A1 FW Change Notification

2022. Aug

Memory Business, Quality Assurance Division

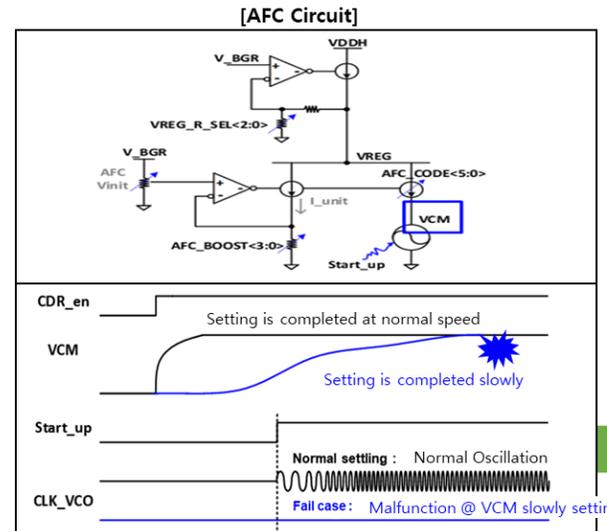
[Fig 2]

[Fail Mechanism]

- 1) SSD exit L1.2
- 2) VCM settling slowly during AFC @ Fail samples
- 3) VCO oscillator malfunctioned due to VCM settling
- 4) Can not meet target Frequency during AFC

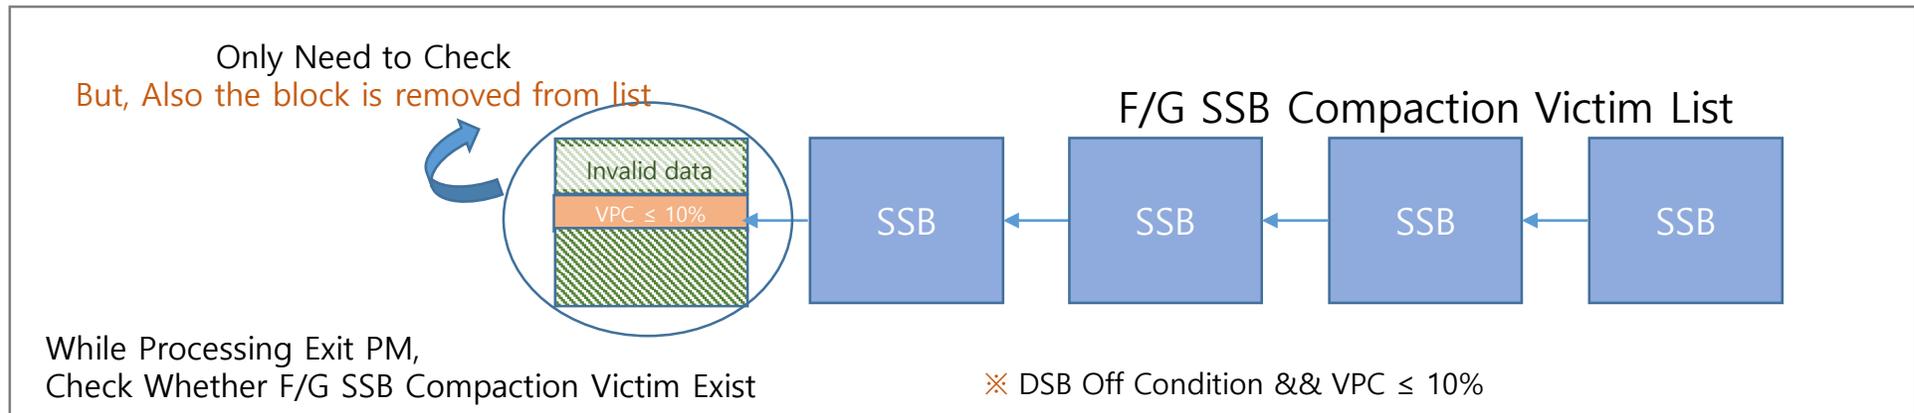
- Seq Write performance was dropped after long idle

- In DSB Off state, Foreground SSB Compaction(a kind of garbage collection) is executed to receive all write data from CDM to SSB as SLC area.
- FW checks the existence of the target block for F/G SSB Compaction in the process of checking whether there is a target SSB to perform F/G SSB Compaction after Exit PM – (Select list for Victim block)
- But FW removed the target block checked from the Compaction Victim List.
- SSB Free block cannot be created because the target block is not selected as Victim of F/G SSB Compaction,
- Finally, TLC write occurred because SSB doesn't have a room for write during CDM and Seq write performance showed TLC performance

- When exit PM(power management mode), FW only check whether the F/G SSB Compaction Victim exists and do not remove it from the list.
